## Effect of Extreme Environmental Thermal Cycling On COTS MEMS Pressure Sensor

**Rajeshuni Ramesham, Ph.D.**  
**Jet Propulsion Laboratory**

**Abstract:** Motorola's Commercial-Off-The-Shelf (COTS) manifold absolute pressure (MAP, 7 – 110 kPa) sensors were subjected to extreme environmental thermal cycling, beyond the manufacturer's specifications of  $-40^{\circ}\text{C}$  to  $+135^{\circ}\text{C}$ , to study how robust the package is. The extreme environmental thermal cycling conditions are as follows:

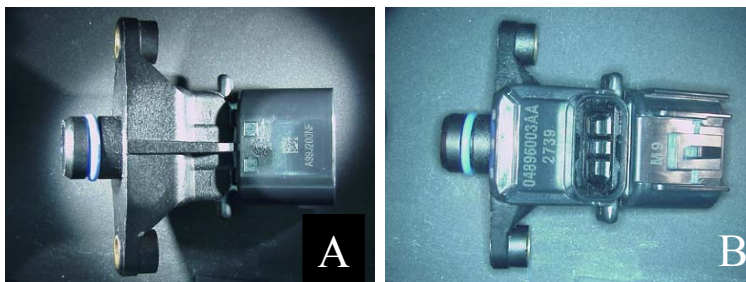
Figure 1: Optical photographs of Motorola's pressure sensor (a) top view and (b) bottom view.

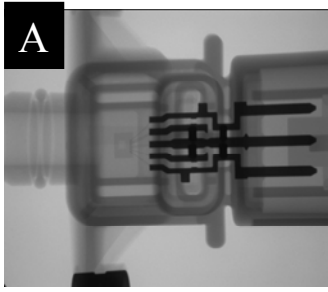
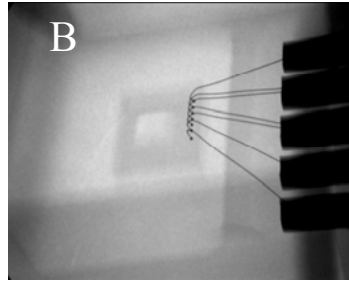
Figure 4 shows the x-ray imaging of the sensor after 15 thermal cycles. There were no failures observed in the sensor or wirebond integrity. We then performed 8 more thermal cycles. As a result of the additional cycling, several of the wirebonds in pressure sensor number 2 were open. This can be seen vividly in the x-ray image of Figure 5. This indicates that the pressure sensors do fail after 15 thermal cycles, however, we do not know where between the 15th and 23rd cycles the failure took place. We have also confirmed similar failures with sensors 3, 4, and 6 as shown in the x-ray image of Figure 6.

Figure 4: X-ray imaging of Motorola's (a) complete pressure sensor and (b) wirebonds in the sensor region where there is a bulk micromachined silicon membrane, after 15 extreme thermal cycles were performed between  $-125^{\circ}\text{C}$  to  $+90^{\circ}\text{C}$  (sensor 2). The dwell time is 10 minutes and the ramp rate is  $7^{\circ}\text{C}/\text{minutes}$ .

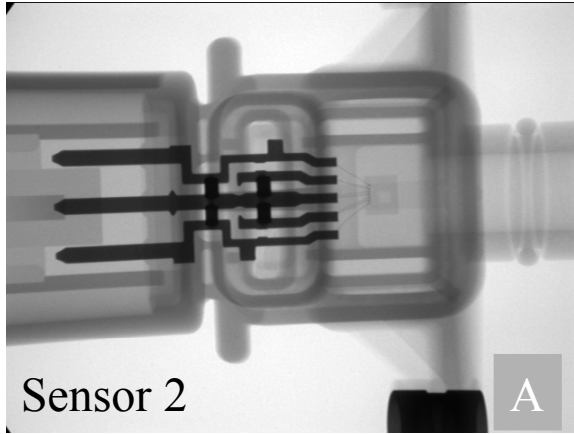
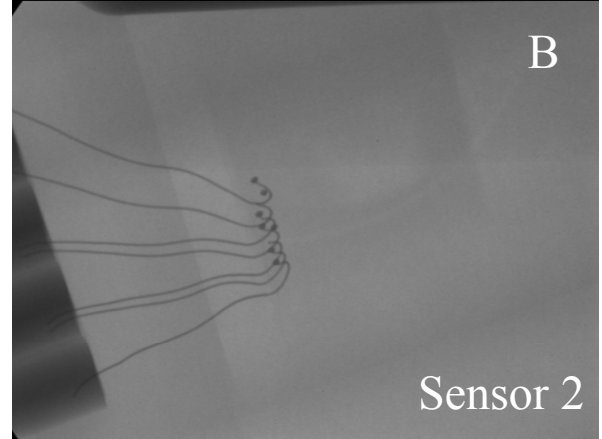
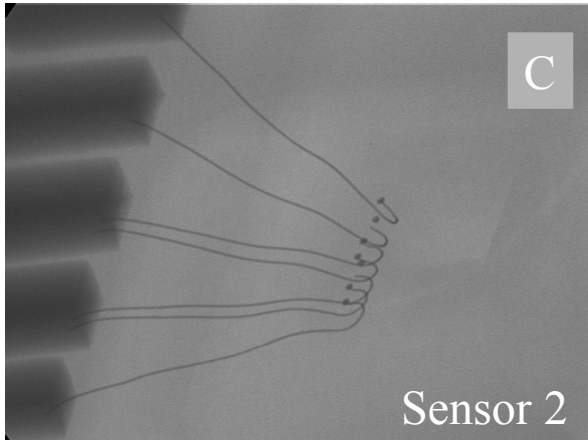
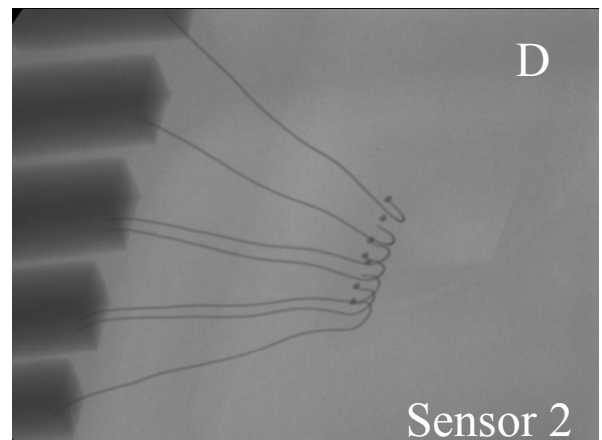
Figure 5: X-ray imaging of the Motorola's (a) complete pressure sensor and (b) wirebonds in the sensor region where there is a bulk micromachined silicon membrane, after 23 extreme thermal cycles performed between  $-125^{\circ}\text{C}$  to  $+90^{\circ}\text{C}$  (sensor 2). The dwell time is 10 minutes and the ramp rate is  $7^{\circ}\text{C}/\text{minute}$ .

**Summary:** Motorola's manifold pressure sensors were subjected to extreme temperature thermal cycling  $-125^{\circ}\text{C}$  to  $+90^{\circ}\text{C}$ . X-ray images of the pressure sensors were taken before and after 15 and 23 thermal cycles. There was no opening of the wirebonds or failures observed after 15 thermal cycles, however, several wirebonds were open after 23 thermal cycles. Therefore, these COTS pressure sensors were not reliable in the extreme temperature range employed in this test.

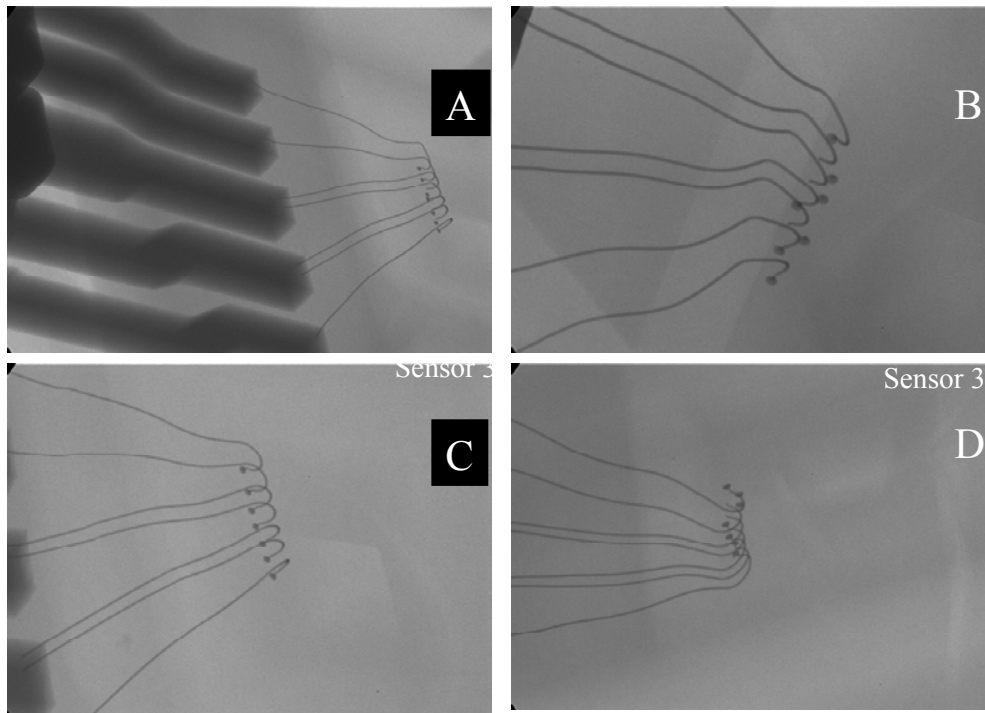
Figure 6: X-ray imaging of the Motorola's (a) complete pressure sensor and (b) wirebonds in the sensor region where there is a bulk micromachined silicon membrane, after 23 extreme thermal cycles performed between  $-125^{\circ}\text{C}$  to  $+90^{\circ}\text{C}$  (sensor 3, 4 and 6). The dwell time is 10 minutes and the ramp rate is  $7^{\circ}\text{C}/\text{minutes}$ .
